**Leak Testing Kitchen Exhaust Systems:
The One Method That Truly Holds Water**

April 2018

Grease Duct

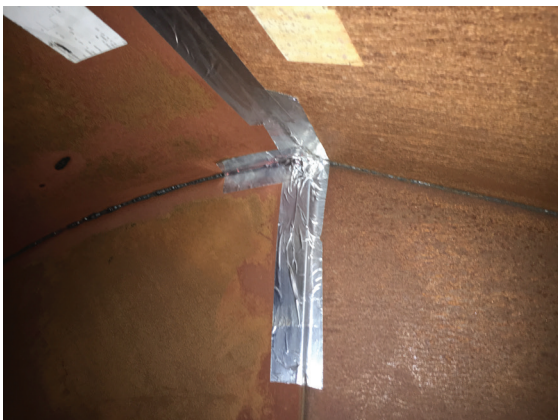
Grease duct seams inappropriately covered with duct tape (typically used for residential clothes dryer exhaust duct), presumably applied to pass a leak test. Photo courtesy of Derby Pressure Wash, Louisville, KY

Finally, sometimes a false pass is not so innocent. Installers have been known to smear flux, silicone and/or epoxy seal over weld joints or place a strip of plain old duct tape over a joint in order to pass a light or smoke test. All of these are quick fixes that will eventually fail.
