Proper picture layout of a properly cleaned grease duct, 2nd picture is the hood at start of job.

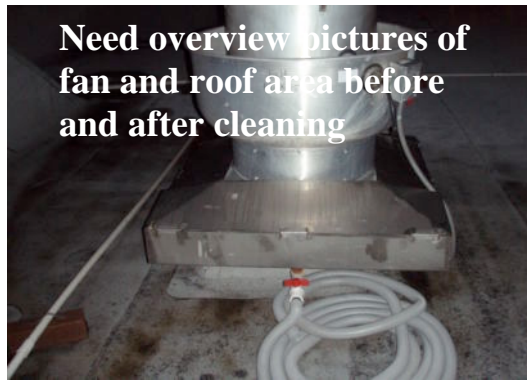
Need overview pictures of fan and roof area before and after cleaning

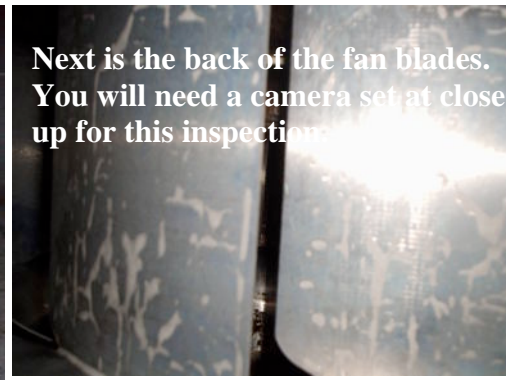
Next is the back of the fan blades. You will need a camera set at close up for this inspection.

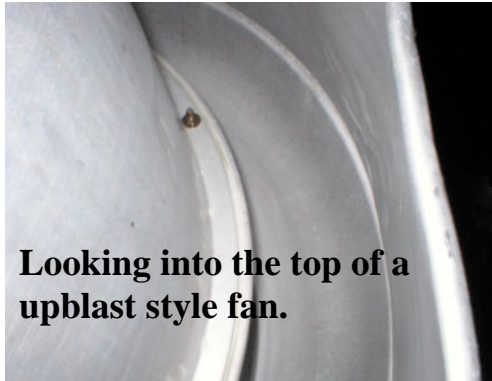
Looking into the top of a upblast style fan.

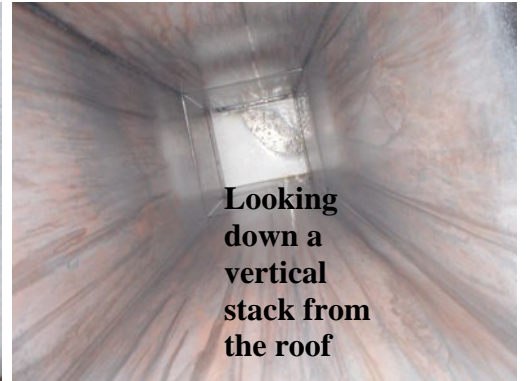
Looking down a vertical stack from the roof

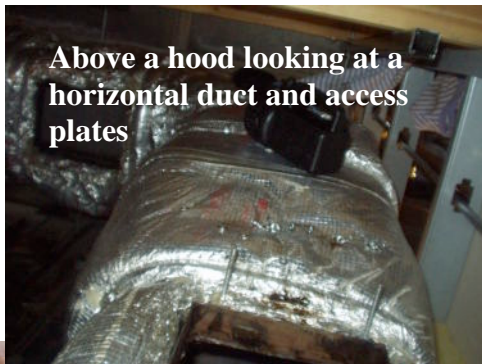
Above a hood looking at a horizontal duct and access plates

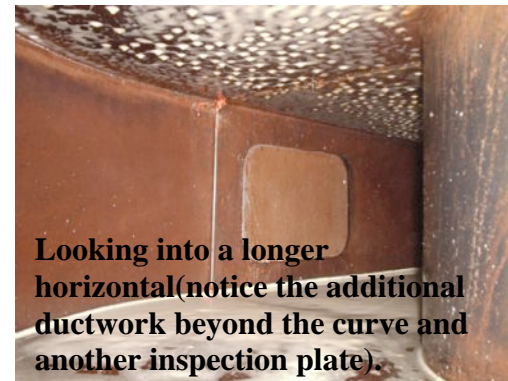
Looking into a longer horizontal(notice the additional ductwork beyond the curve and another inspection plate).

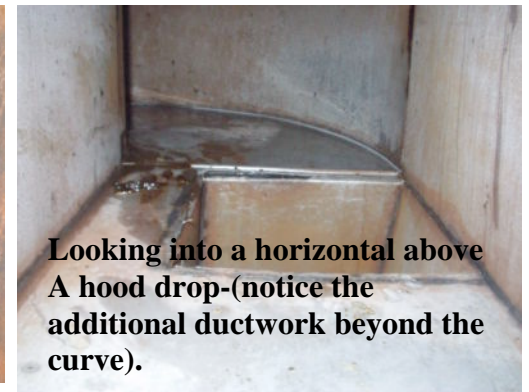
Looking into a horizontal above A hood drop-(notice the additional ductwork beyond the curve).

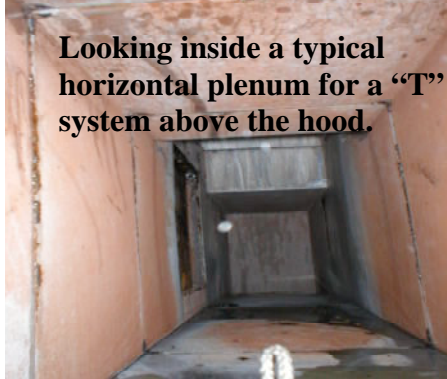
Looking inside a typical horizontal plenum for a "T" system above the hood.

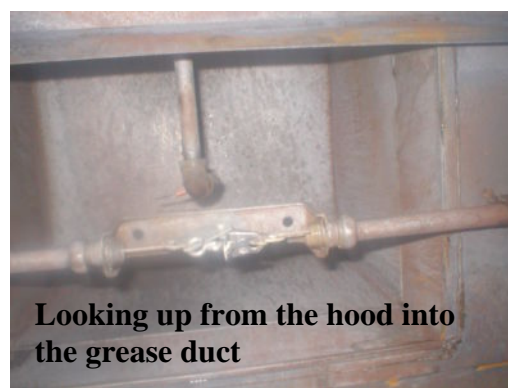
Looking up from the hood into the grease duct

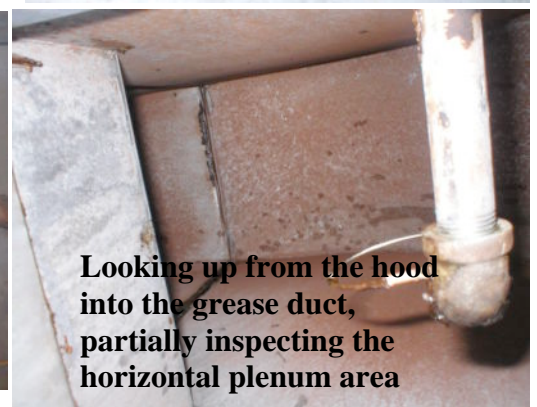
Looking up from the hood into the grease duct, partially inspecting the horizontal plenum area

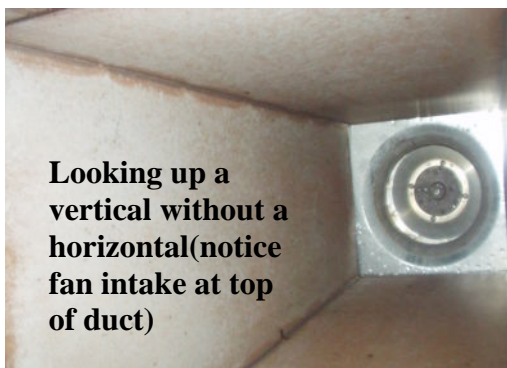
Looking up a vertical without a horizontal(notice fan intake at top of duct)

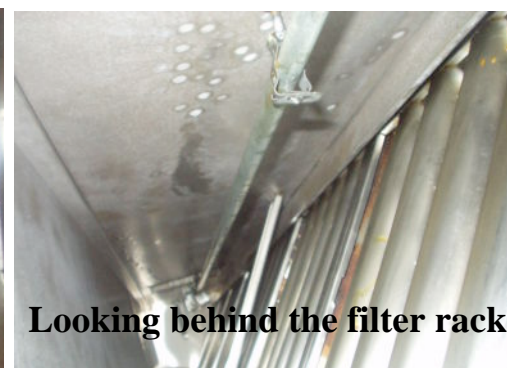
Looking behind the filter rack

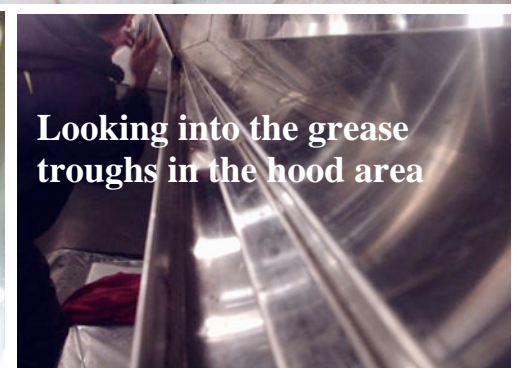
Looking into the grease troughs in the hood area
